Periodic Inspection Report No. 4
West River
Townshend, Vermont

Townshend Lake

October 1996

US Army Corps
of Engineers

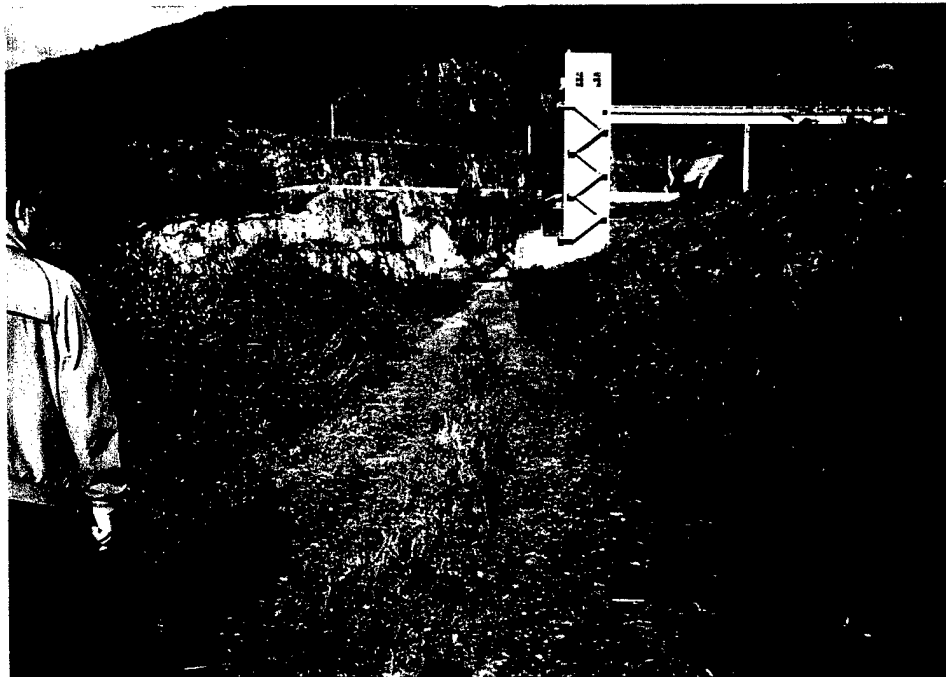
PHOTO E-6: Upper level of upstream impervious blanket. Note sapling at top of riprap slope.

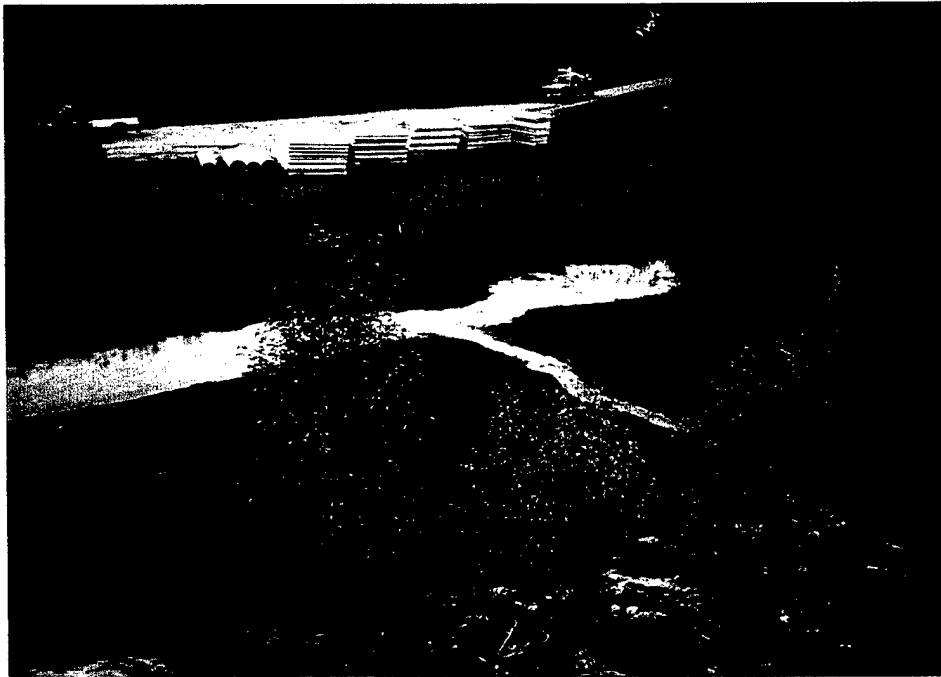
(d) Exit Channel. Concrete of the outlet portal, sidewalls, and apron is in good condition. The exit channel was clear. The scour hole formed in the outlet channel, extending about 140 feet downstream of the outlet works, has been surveyed. Stabilization of the banks was under way the day of the inspection. A new weir for the seepage pool is also being built. See photo E-10, Appendix II.

PHOTO E-10: View of seepage pool and outlet channel. Note seepage at downstream toe.
